Flow Chart of the E-Commerce Video Editing Tool

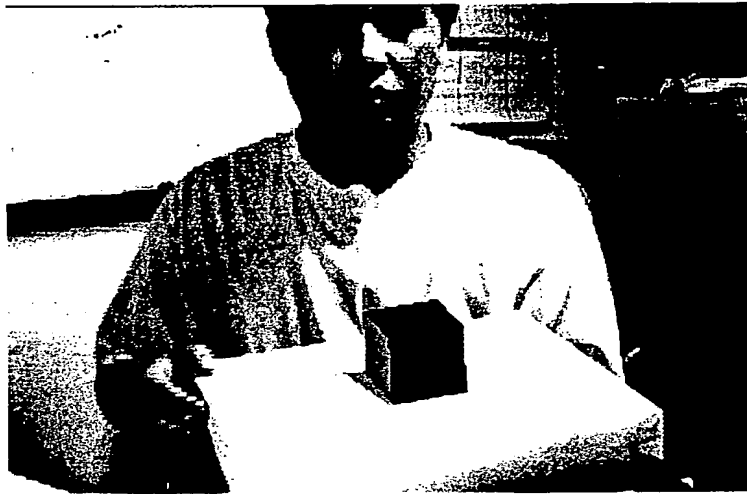
Figure 6. A color cube augmented on top of the model plane using OpenGL rendering with a fake shadow.

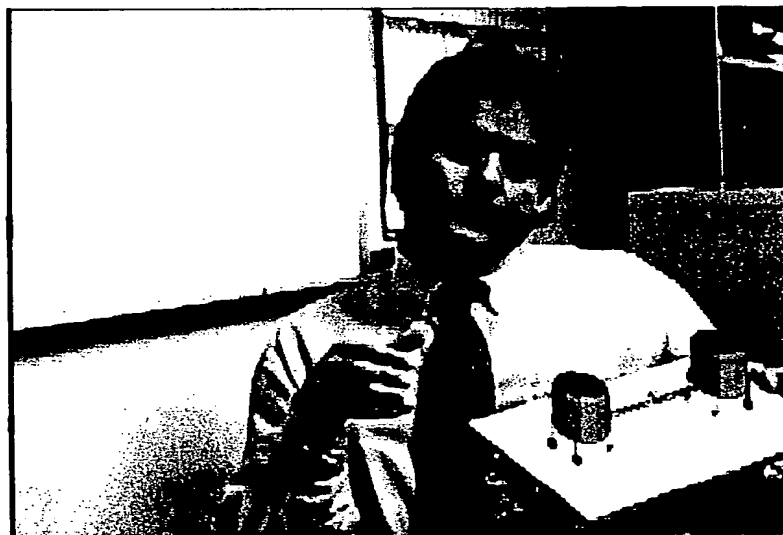
Figure 7. Augmented with 2 huge tanks with connection between them.
The VRML model is scaled down.
